# EVIDENCE MATTERS

## RESEARCH BULLETIN

### Bone Ongrowth Around Retrieved ICONIX Anchor

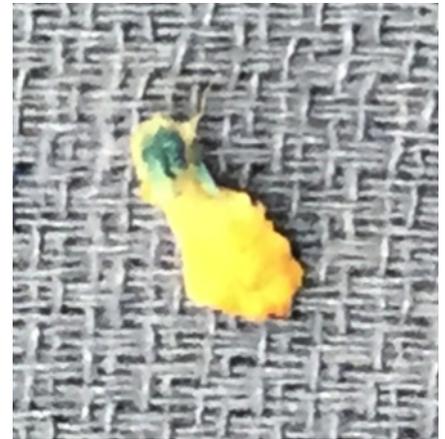
A 52 year old female was injured at work in December 2013. MRI revealed a partial tear of the supraspinatus. After conservative management failed, a left rotator cuff repair with arthroscopic subacromial decompression was performed in September 2014 for a full thickness supraspinatus tear. At 2 months post op, pain recurred and MRI showed a recurrent tear. In February 2015 a repeat repair revealed intact anchors and suture knots with a large recurrent supraspinatus tear at the suture-tendon interface. This interface remains the “weak link” in rotator cuff repair.<sup>1,2</sup> The ICONIX anchor was forcefully removed from the greater tuberosity leaving a perfectly round hole which accepted a 5.5mm corkscrew anchor. As seen in the photo to the right, significant bone tissue ongrowth was noted around the anchor.
